Manhole Inspection Summary

Manhole # **S33AA_020MH**

Insp Date: **10/15/07 11:35 AM**

Location Address: **214 MADISON ST**

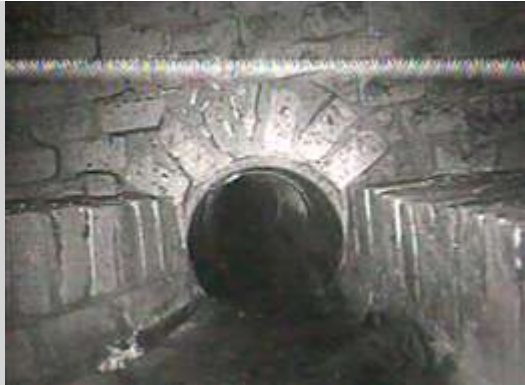
12 O'Clock Outflow

10 in. Circular Gravity Sewer
Pipe Out @ 12 O'Clock

Pipe Height: (in.) Direct
Pipe Material: **Clay** ☐ Pipe Lined
Invert Depth: **12.89** (ft.) Flow Characteristics: **Slow**
Deposits: ☒ None ☐ Mud ☐ Sludge ☐ Debris ☐ Grease
Silt Depth: (in.) Deposits Extent:
Infiltration: **None** Pipe Seal Cond: **Sound**

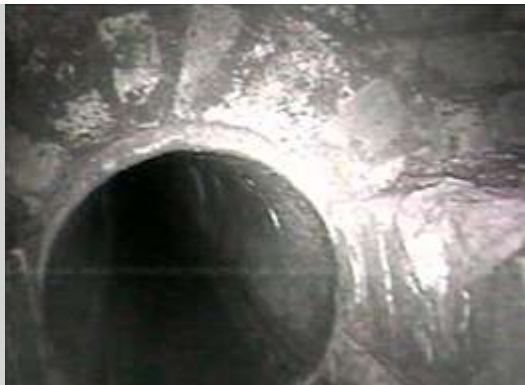
6 O'Clock Inflow

10 in. Circular Gravity Sewer
Pipe In @ 6 O'Clock

Pipe Height: (in.) Direct
Pipe Material: **Clay** ☐ Pipe Lined
Invert Depth: **12.09** (ft.) Flow Characteristics: **Slow**
Deposits: ☒ None ☐ Mud ☐ Sludge ☐ Debris ☐ Grease
Silt Depth: (in.) Deposits Extent:
Infiltration: **None** Pipe Seal Cond: **Sound**

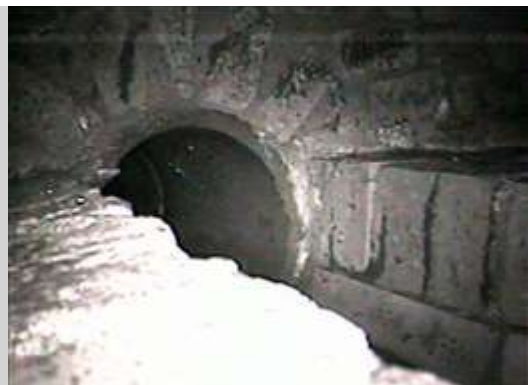
9 O'Clock Inflow

8 in. Circular Gravity Sewer

Pipe In @ 9 O'Clock

Pipe Material: **Clay** ☐ Pipe Lined

Invert Depth: **12.53** (ft.) Flow Characteristics: **Slow**

Infiltration: **None** Pipe Seal Cond: **Sound**
